Judge Illston,

With respect to your sentencing decision for Rodrigo Santos, I would like to anonymously provide the following verifiable information for context—

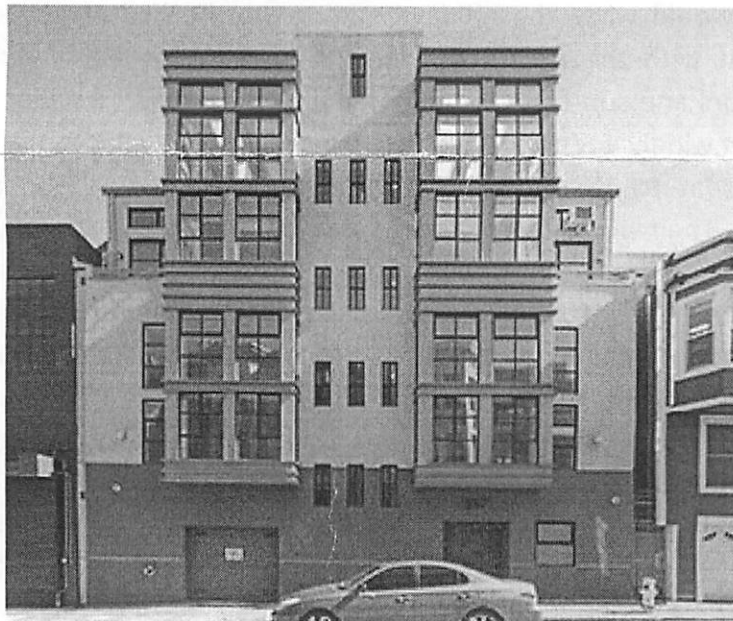
- Projects like 637 Natoma Street, pictured below, are so obviously lacking a credible seismic system it is amazing that they got through the system.

A cursory review of DBI's website shows that the only DBI inspections on this project were a single rebar inspection by Ed Sweeney on 02/07/2001 and two lath inspections by Ed in January of 2002. Ed Sweeney rarely left the building at DBI, so it is a little unusual that he would show up for these inspections. All the Special Inspections were signed off by Tom Hui, which is also unusual since Tom Hui was a plan-checker at that time, *not a building Inspector*. Tom Hui's facilitation of years of fraud is widely known at this point.
